PHASE I INSPECTION REPORT
NATIONAL DAM SAFETY PROGRAM
HELDERBERG LAKE DAM I.D. NO. 276
DEC # 190D-1294 LOWER HUDSON RIVER BASIN
ALBANY COUNTY

PHASE I INSPECTION REPORT
NATIONAL DAM SAFETY PROGRAM

Name of Dam:	Helderberg Lake Dam(I.D. No. NY 276)
State Located:	New York
County Located:	Albany
Stream:	Onesquethaw Creek
Dates of Inspection:	November 27, 1979, January 25, 1980

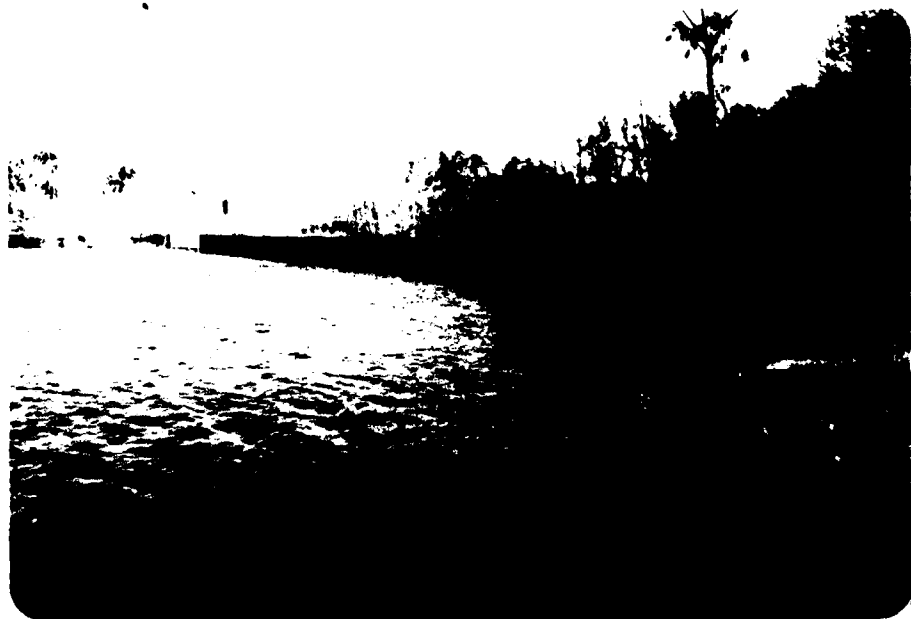
The earth embankment shows no signs of major distress, some erosion is taking place near the left spillway abutment (See Photo #13) and along each side of the channel walls. Erosion on the downstream slope can be seen on Photo #10. Trees and low brush were growing on both sides of the downstream slope, there were also some trees on the crest of the dam. The concrete core wall which is exposed on the upstream side of the embankment and also acts as a wavebreak appears to be in good shape with little deterioration. (See Photo #3)

Photo #3
Upstream Face

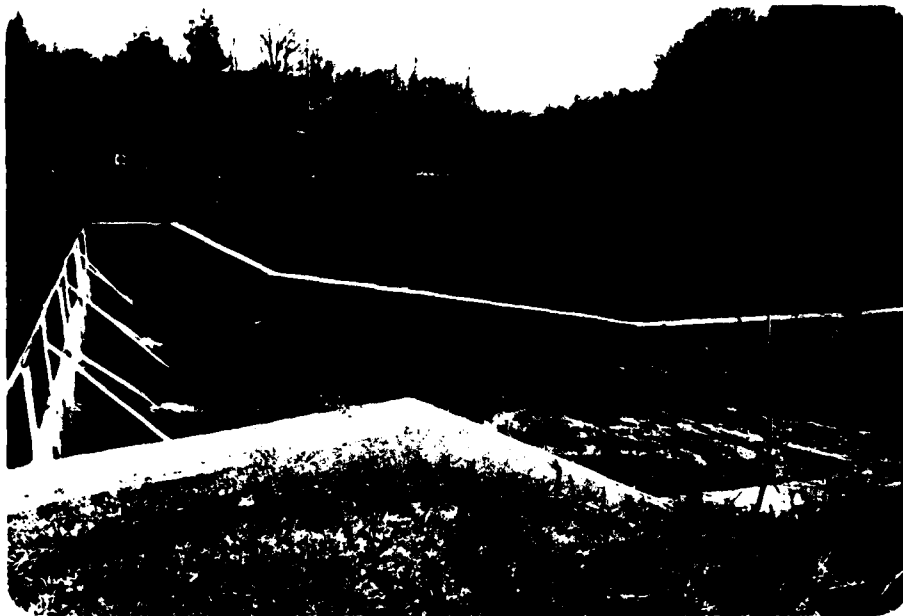
The uncontrolled spillway is located on the left side of the embankment and appears to be founded on shale and sandstone bedrock. The concrete is in generally good condition, although some movement and cracking of the spillway slab and walls was noted. Different movement of the spillway walls up to 1/2 inch was observed. This movement is believed to be related to backfill pressures, but is not considered a significant problem at this time. (See Photos #4 & 6)

Photo #4
Spillway & left Abutment

3. Repair the cracked and deteriorated portions of the spillway walls and slabs. Monitor these walls for signs of ongoing movement.
4. Restore the masonry wall and the reservoir drain to operating condition.

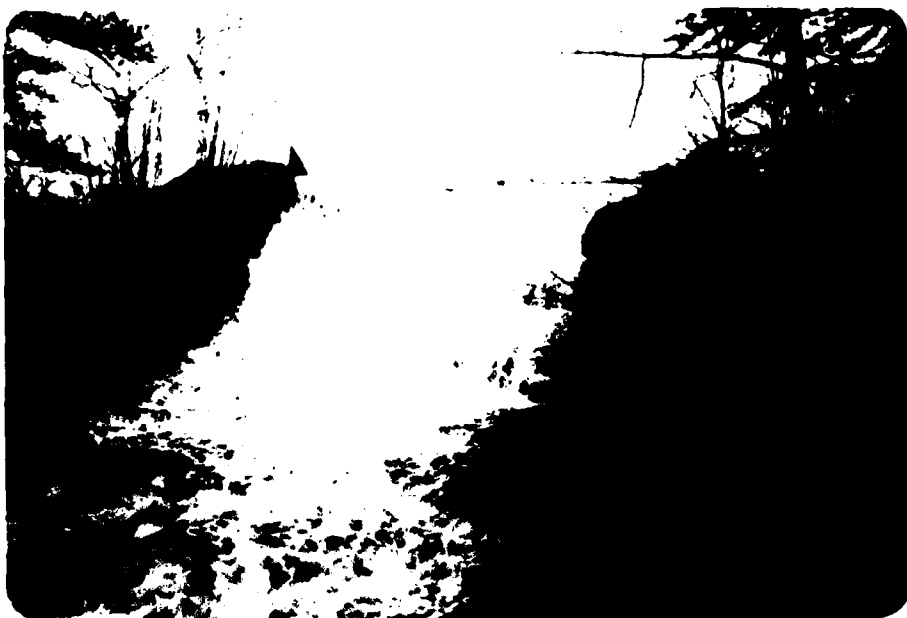
The downstream channel is shale and sandstone bedrock. While some surface erosion of the channel slopes was observed, due to the steep slope, significant erosion affecting the stability of the spillway is unlikely due to the integrity of the bedrock. (See Photo #5)

Photo #5
Downstream Channel

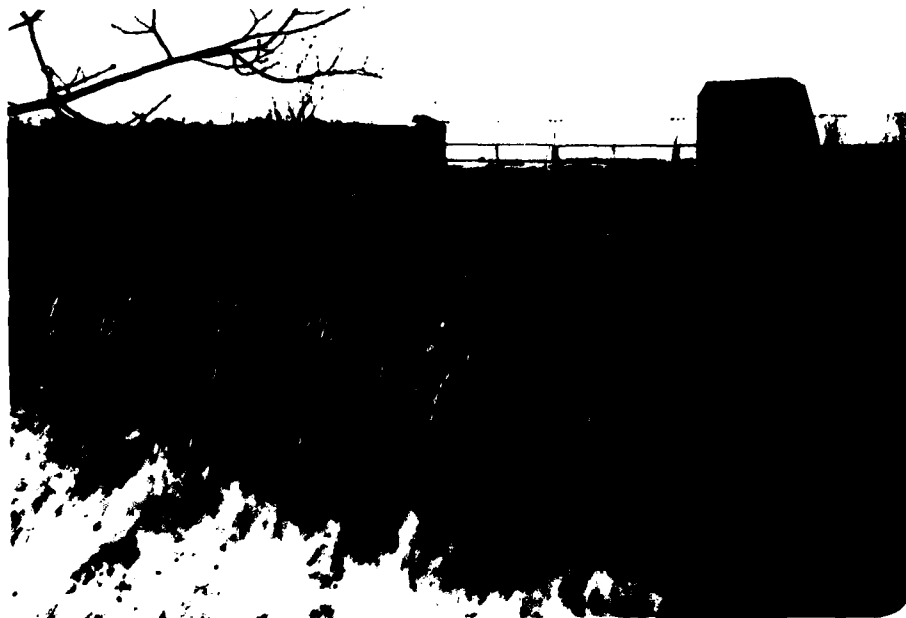
Erosion of the original grade on the left side of the spillway was evident and should be monitored periodically. (See Photo #6) The downstream slope on the right side of the spillway is very steep and should also be monitored for signs of erosion. (See Photos #8, 9 & 10)

Photo #6
Spillway
Note Crack in Wall
